Carolyn S. Snively

THE EPISCOPAL BASILICA, THE VIA SACRA, AND THE SEMICIRCULAR COURT AT STOBI, R. MACEDONIA

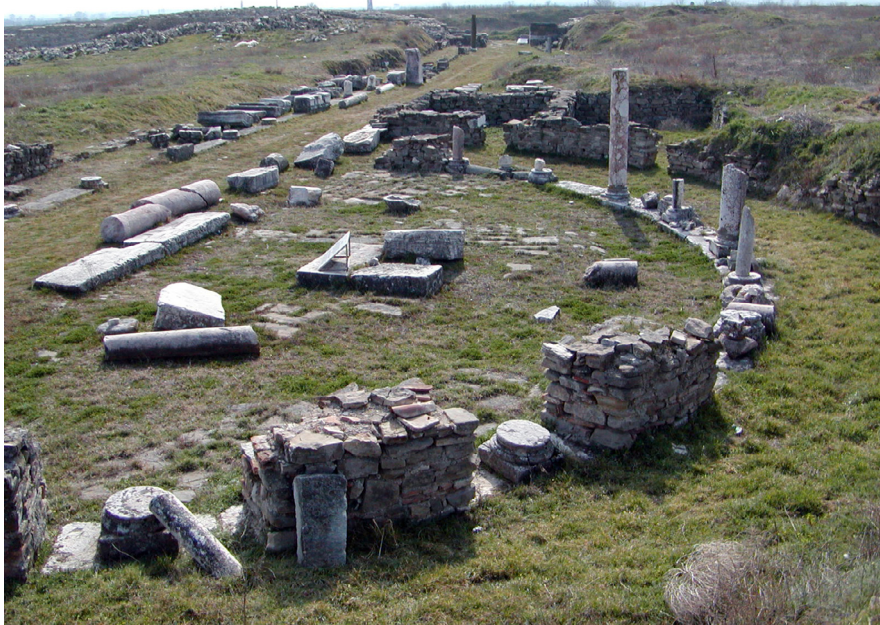
Fig. 4. The Semicircular Court, the Via Sacra, and in the background the Porta Heraklea.
From the north, March 2003.

outer edge of the portico, from which several rooms were accessible through doorways. Columns and piers stood on a stylobate made of re-used marble Theater seat blocks that rested on a foundation wall. In the middle of the courtyard, three marble blocks may once have supported the base for a statue.¹¹ At the front of the courtyard, along the Via Sacra and directly opposite the entrance to the Episcopal Basilica, two additional marble blocks (re-used Theater seats) demarcated the east edge of the courtyard; other marble blocks marked the north and south ends of the portico. The courtyard had been paved with square and rectangular sandstone slabs, of which a large number remained *in situ*. (Fig. 4)

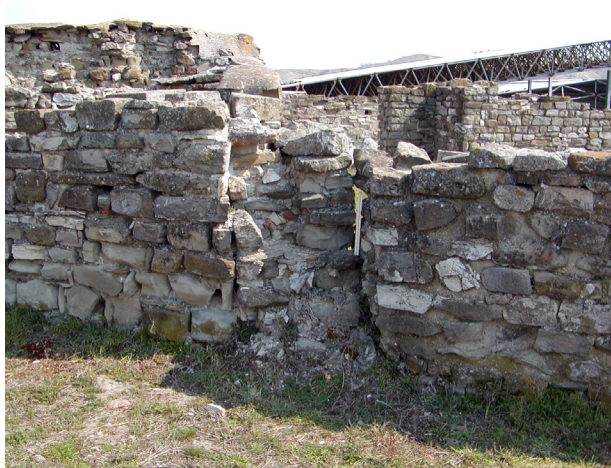
Fig. 6. The Semicircular Court from the west, looking across the Via Sacra to the west façade of the Episcopal Basilica and its entrance. X marks truncated Wall 10a. From west, March 2003.

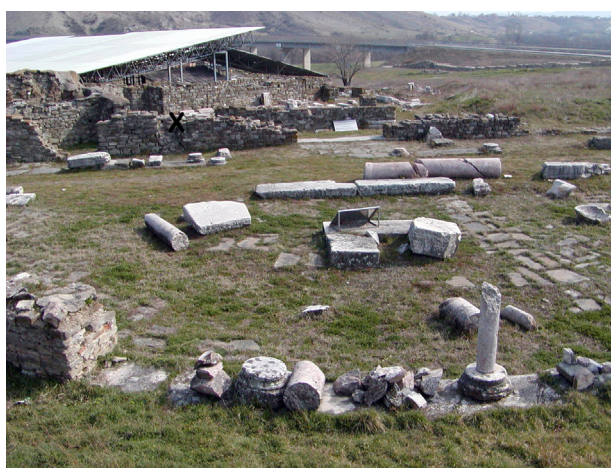
Fig. 7. The north half of the Semicircular Court, the Via Sacra, and the north part of the atrium complex. From west, March 2003.

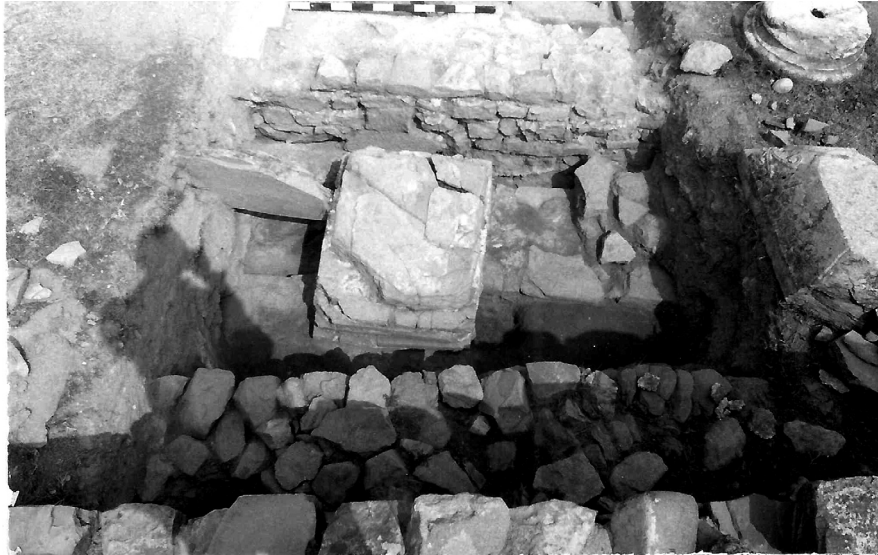
Fig. 9. T-79-7b, the trench in the portico north of the entrance to the atrium. The meter stick rests on Wall 1 in the background; the pier rests on Wall 81, and the broken screen slab is visible running into the scarp at the left. From east.

Three piers were discovered in a row in front of the later entrance to the church, and the existence of others has been hypothesized. The first pier was found in T-79-7b, just north of the entrance to the atrium. The bottom of a broken screen slab ran south from the pier into the scarp; a very soft narrow deposit to the north of the pier suggested that another slab and therefore another supporting pier had stood to the north. Part of a pier was found in T-77-3, just south of the entrance to the atrium. A third pier came to light in 2003 during conservation of the stone paving at the entrance to the basilica;²¹ a rather battered foundation extended south from this middle one, possibly for a threshold block.
