Vassil Tenekedjiev (Varna Regional Museum of History)

ANOTHER LOOK AT THE LARGE BASILICA IN MARCIANOPOLIS: THE PROBLEMS OF ITS CONSTRUCTION AND DATING

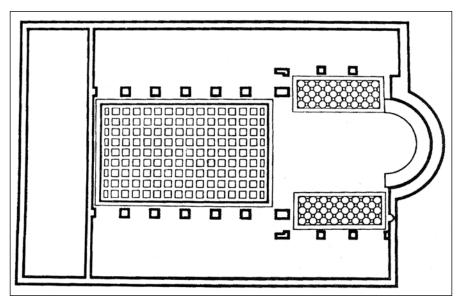
Fig. 1. Ground plan of the Large Basilica in Marcianopolis (after N. Chaneva Dechevska)

Here is an opportune place to mention that there is only one plan of the Great Basilica in the available scientific literature. It was published by Nely Chaneva-Dechevska and is based on information provided by G. Toncheva and V. Popova (Fig. 1)⁹. The plan only gives a general idea of the site and is inaccurate, incomplete and misleading in many respects.

The ground plan on Fig. 3 had some additions based on the information in the journal and the available pictures. They are presented with dotted lines. Also the northernmost of the four column pedestals and the altar base were moved to their presumably original places.

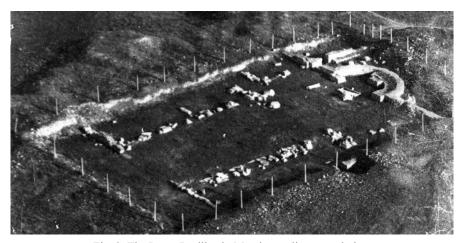
Fig. 2. The Large Basilica in Marcianopolis, general view (Photo album, a processed photo without a number.)Сл. 2. Велика базилика у Марцианополису, општи изглед (фото албум, без броја)

was left uncovered, exposed to the elements and accessible to visitors (Fig. 2). Therefore, parts of the mosaics were further damaged and some marble details were moved. There is no information as to whether any field conservation of the walls was carried out, but there are currently no traces of such work. It was later decided to protect the mosaics by burying them with soil, but the building walls were left uncovered¹⁰.

There is a solid synthronon along the apse's inner wall (Fig. 2 and 8). It is about 0.90 m wide, with the ends projecting about 0.50 m in front of the altar conch. The width of the bottom step measures at about 0.32 m. Thus the synthronon could be reconstructed with three steps. Only the projecting ends of the structure were without steps. A trapezoidal platform was built in the middle of the synthronon for a bishop's throne hypothetically with three tapering steps in front. The front of the bottom one is 1.25 m. The upper part of the overall fixture is heavily damaged, and the heights cannot be measured accurately.

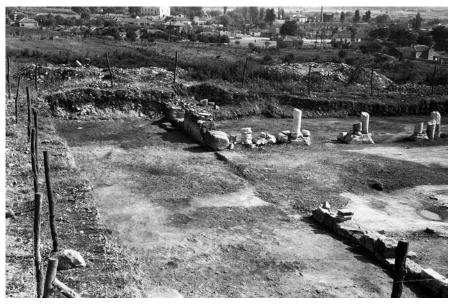
Fig. 5. The narthex, general view from the south (Photo album, page 2, row 1, pic. 1) Сл. 5. Нартекс, општи изглед са јужне стране (фото албум, страна 2, ред 1, сл.1)

The narthex is rectangular and 23.55 m wide (north-south) and 5.40 m long (east-west) on the inside (Fig. 5). It appears to have been made as a single piece because there are no remains of walls, pilasters or other types of supports that would have divided it into parts¹⁷. However, given how little of the wall

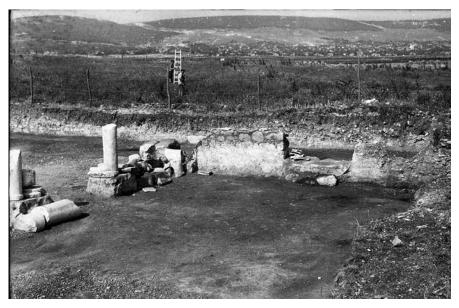
Fig. 6. The entrance from the narthex into the north aisle, view from the east (Photo album, page 1, row 2, pic. 1)

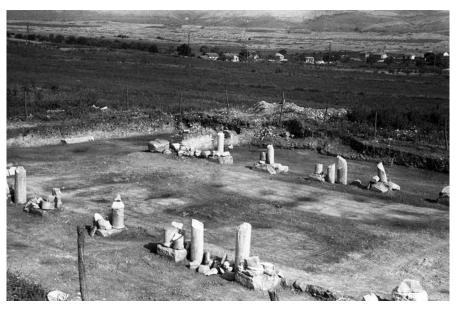
Fig. 7. Western half of the basilica's nave, general view from the southeast (Photo album, page 2, row 1, pic. 5)

The naos is rectangular and 23.55 m wide and 27.16 m long on the inside. It is divided into three bays by two load-bearing colonnades (Fig. 7). At its eastern end, the rhythm of the colonnades is broken by a transverse nave, otherwise known as a transpet (Fig. 8). This is the main architectural feature of the

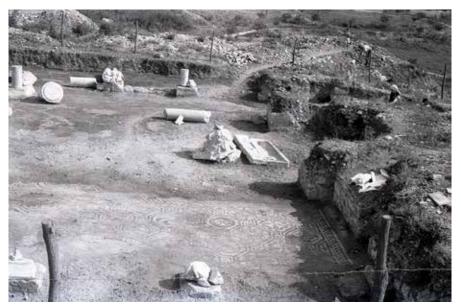
Fig. 8. The transept, view from the south (Photo album, page 11, row 4, pic. 4.) Сл. 8. Трансепт, изглед са јужне стране (фото албум, страна 11, ред 4, сл. 4)

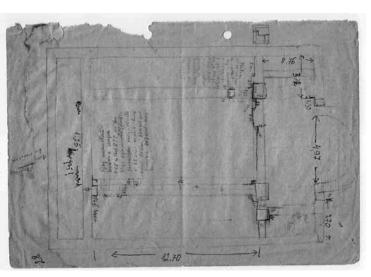
Fig. 9. Sketch from the *Journal* presenting the foundation walls under the colonnades (Journal, O.p.n.: year 1957 and 1958, 28.)

A sketch in the journal shows foundation walls²³ under the vertical supports inside the building (Fig. 9). Two of them are beneath the colonnades be-

tween the nave and the aisles; one crosses the entire naos from north to south along the line where the transept begins; two more start from this wall and extend eastwards under the lateral colonnades of the transverse nave. According to the disthe foundation coverers. walls under the long colonnades are 0.95 m wide and 0.55 m deep. As far as it can be made out from the notes on the sketch, the transverse foundation wall is 0.70 m wide and those under the transept's colonnades - 0.90 m²⁴.

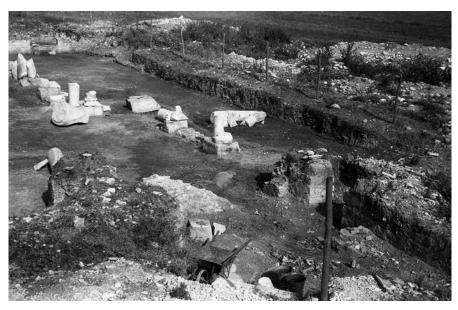
Fig. 17. Entrance on the north side of the apse with part of the premises adjacent to the basilica's eastern façade, view from the east (Photo album, page 1, row 4, pic. 5.)

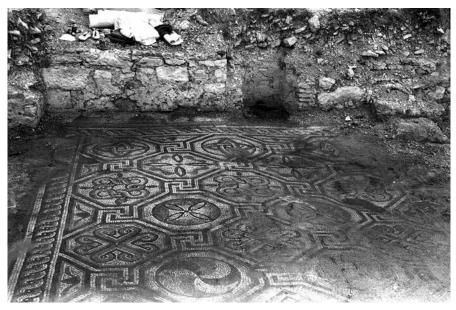
Fig. 18. Entrance on the south side of the apse, sealed and transformed into a semicircular niche, view from the west (Photo album, page 6, row 4, pic. 6.)

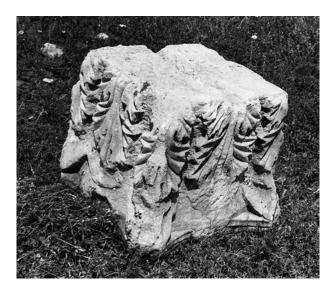
Fig. 22. Marble Roman-Corinthian pilaster capital (Photo album, page 6, row 4, pic. 3.)

capital with an eagle⁴² and a fragment of a Roman-Doric capital from the 2nd or early 3rd century (Fig. 21)⁴³. Only one pilaster capital, which is decorated with acanthus leaves, was discovered (Fig. 22). It can be dated back to the 2nd century and has therefore been reused in the church⁴⁴. Six imposts were also found in the basilica⁴⁵. Two of them are decorated with stylised acanthus leaves and crosses (Fig. 23), and the third with flutings. They can be dated back to the second half of the 5th⁴⁶. The rest of the preserved imposts are without decoration. In terms of size, the imposts vary, but can be successfully combined with the small Roman-Corinthian capitals⁴⁷.

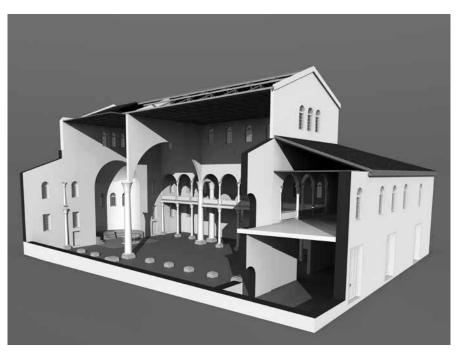
Fig. 25. Hypothetical reconstruction No 1: with a gallery, interior (Architect R. Demirova) Сл. 25. Хипотетичка реконструкција No 1: са галеријом , унутрашњост (арх. Р. Демирова)

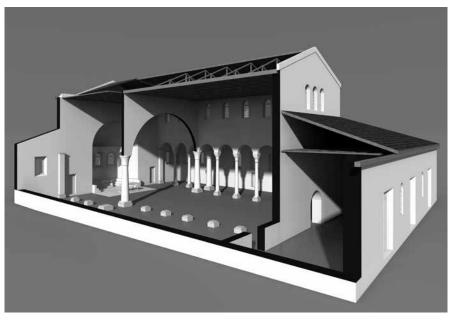
Fig. 26. Hypothetical reconstruction No 2: without a gallery, interior (Architect R. Demirova) Сл. 26. Хипотетичка реконструкција No 2: без галерије, унутрашњост (арх. Р.

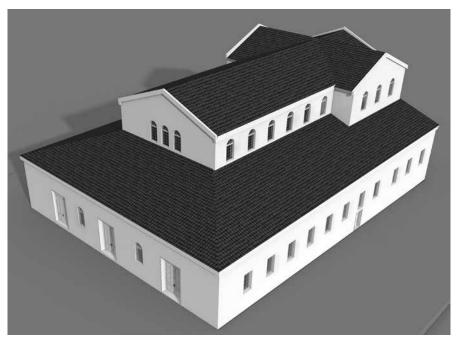
Fig. 27. Hypothetical reconstruction No 2: without a gallery, exterior (Architect R. Demirova)

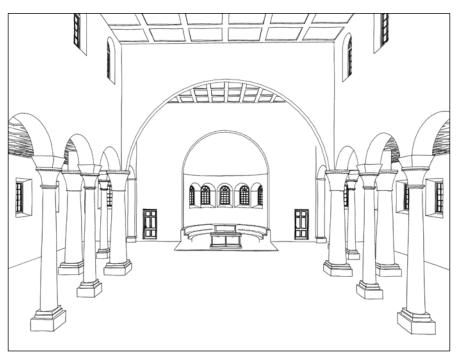
Fig. 28. Hypothetical reconstruction No 2: without a gallery, view from the interior (Architect R. Demirova)
