EARLY CHRISTIAN ARCHITECTURAL COMPLEX IN SOFIA (BULGARIA)

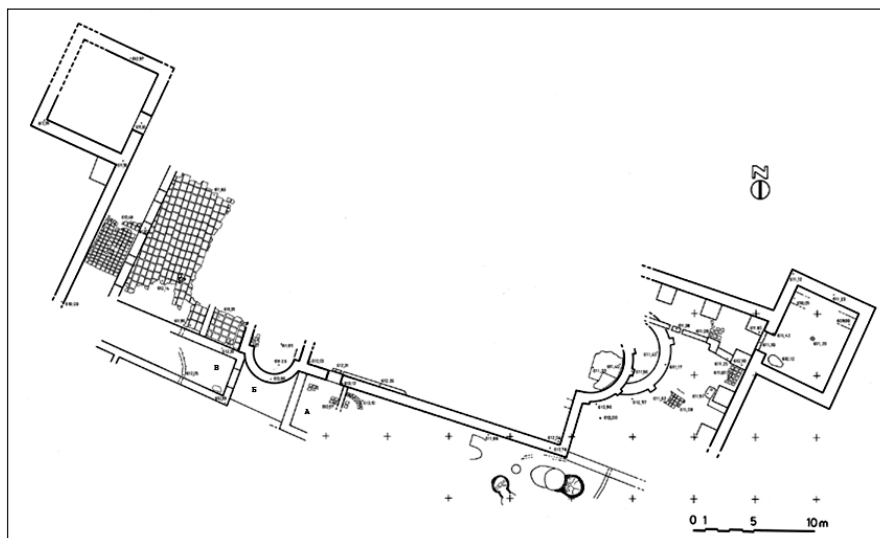
Fig. 1. Plan of the excavated parts of the architectural complex.

The excavations were carried out next to the modern building on an area of ca. 900 sq. m. (fig. 1). The main periods of occupation and construction of the complex were defined⁴. The main periods of the sequence from bottom to top are as follows:

Several rooms were unearthed to the south of the basilica. They are designated from east to west with the Cyrillic letters A, Б and В (fig. 1 and 2).

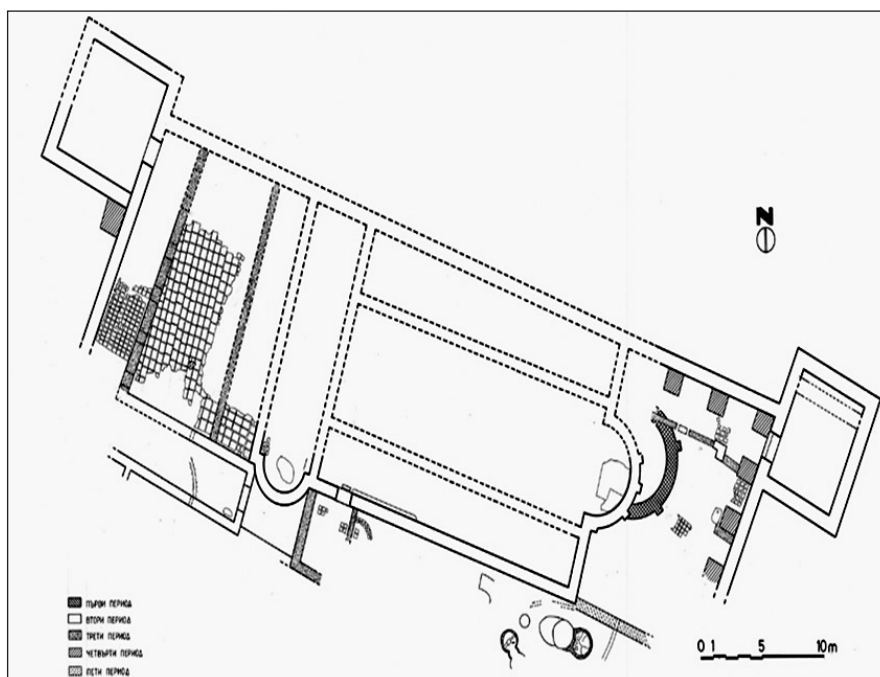
Fig. 2. Reconstructed plan of the two churches with their construction phases and functioning.

The paper is aimed at presenting the two consecutive Christian complexes, which have been built up and functioned during the reign of Constantine the Great and his descendants (fig. 2).

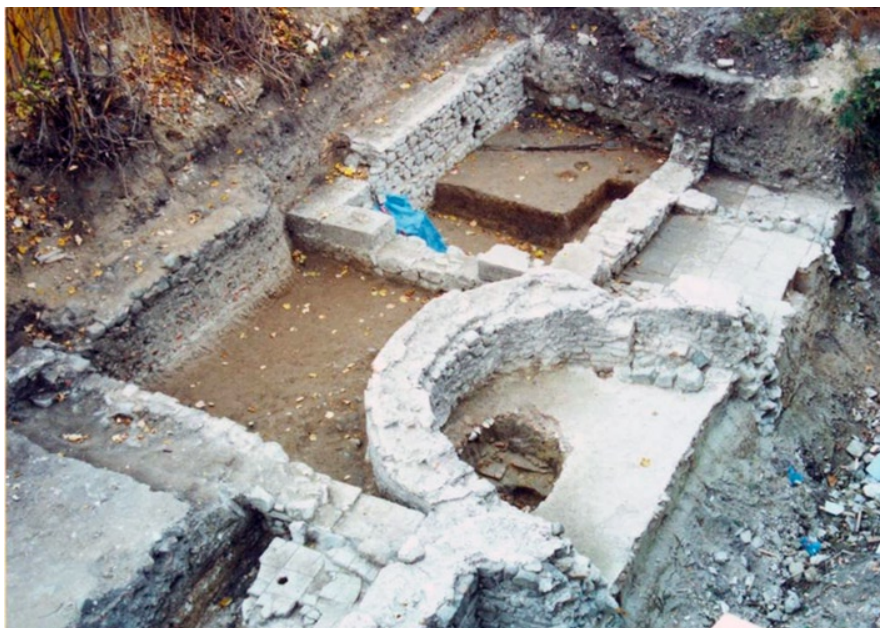
Fig. 3. Surviving part of the narthex with the southern conch and parts of the premises to the southwest of the basilica.

The basilica has a narthex to the west. No information about its internal division has been provided by the excavations. The narthex ends to the south with a semicircular conch with a diameter 3.5m. However, it is not clear whether there was a second conch at the opposite end or the basilica was asymmetrical in plan. The narthex without the conch was probably as wide as the naos and 4.2m long. There was a deep narrowing down oval pit in the conch floor, which was filled in with construction wastes only; no other materials were found there. It is possible to assume that the pit was related to the *mensa martiriae* (fig. 3).

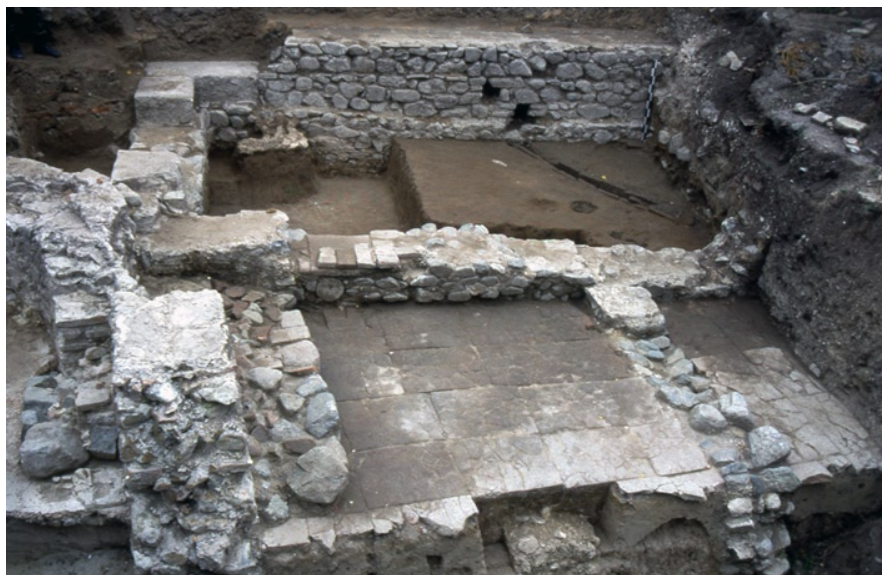
Fig. 4. The southern part of the portico in front of the basilica's entrance.

An open portico (2.8m wide in the southern part and 2.4-2.5m wide in the northern one) existed in front of the western façade of the basilica (fig. 4). The wall discovered here was interpreted as a stylobate based on its shallower foundations. A bed of a column base as wide as the stylobate is preserved in its southwestern corner. The portico was constructed later than the basilica and the courtyard in front of the western façade. This conclusion is based on the fact that the stylobate foundations disturb the floor cover of the portico and the courtyard made of bipedal bricks measuring 0.52 x 0.60m.

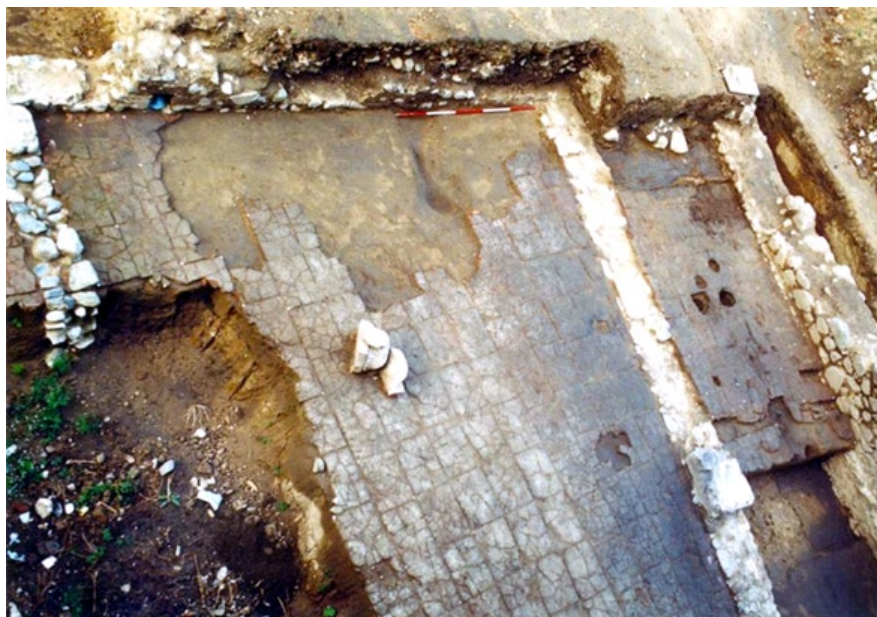
Fig. 5. The atrium with the tile cover.

There is an atrium to the west of the portico (fig. 5). It is trapezoid in shape and has the following dimensions: length along the north-south axis – 16m, width – 10.5m (at the south end) and 8.5m (at the north end). The atrium was covered with bipedal bricks carefully arranged in north-south oriented rows. The tegulae are placed directly on a leveling layer of sandy soil and the gaps

between them are filled in with a fine grain mortar mixed with a large amount of crushed brick. The courtyard level is 0.25-0.30m slanting down from south to north, where probably the rain and snow water was cached and directed outside the enclosure wall. To the south the atrium abuts a room, to the west and probably to the north it abuts a portico leading to the enclosure wall of the complex. No well was found in the atrium.

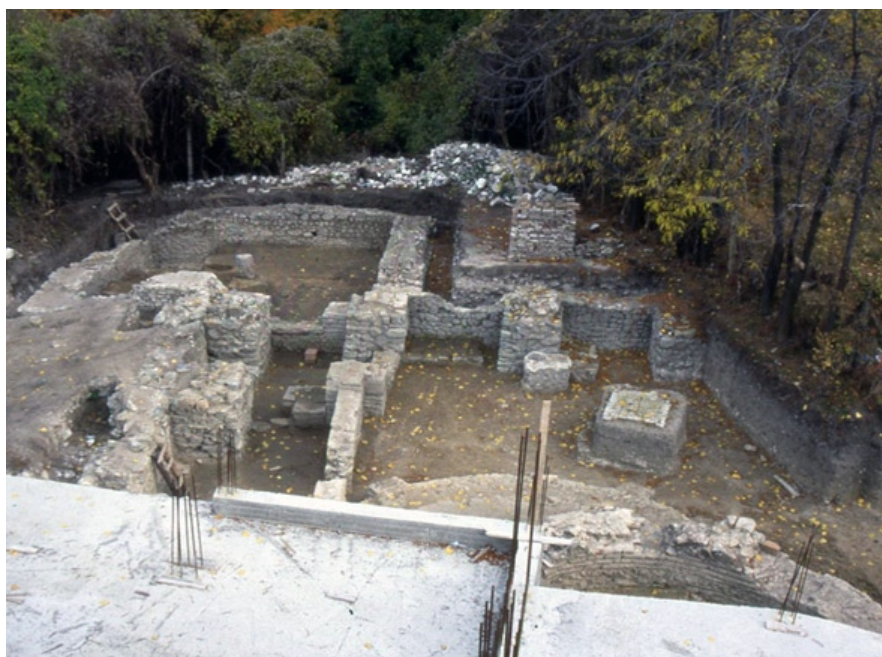
Fig. 6. The northeastern tower, parts of the northern and the eastern enclosure walls and the attached elements.

The northeastern tower is connected with the northern and the eastern enclosure walls (fig. 6). It is rectangular in plan and its outer dimensions are 9 x 7.5m. The thickness of the walls is identical to the one of the fence. The original plan of the tower was a quadrangular one measuring 7.5 x 7.5m. It was enlarged 1.5 m to the north during the construction probably in pursuit of constructing

the body of the tower before the front of the northern curtain and in search of stability of the terrain. A joint is clearly visible at the outer side of the original delineation. The tower was constructed in the *opus mixtum* technique. The front part of the stones is carefully dressed. Bricks were used to construct the corners and the sides of the entrance (1.58m wide). The joints are as wide as the bricks and most probably the same masonry continued along the complete height of the opening. The western side of the threshold is also made from bricks. A massive stone threshold, whose size matches the size of the entrance and the height of the brick threshold, was found in the excavated soil (1.48-1.5m long, 0.64-0.65m wide and 0.40-0.42m high). Holes (5-8cm in diameter) for the axes of a two-folding door are visible at both ends. Stone quadrae had been used for the construction of the northeastern corner of the tower.

Blocking, partition and additional walls were found in all excavated parts of the enclosure. South of the northern wall at a distance of 2.9m a parallel wall 0.44-0.45m thick was built up. Its western part is on top of the apse of the earlier church and extends to the eastern wall of the northern nave of the basilica. It abuts at east an L-shaped pilaster measuring 1.05 x 1.05m (at the outer side), 0.55m (to the west) 0.65m (to the south). Its eastern side is abutted by a wall similar in construction but a bit wider (up to 0.6m) reaching the inner face of the eastern enclosure wall. Its foundations are ca. 0.65-0.75m shallower than the foundations of the basilica, the enclosure walls and the above mentioned L-shaped pilaster. It is difficult to offer an interpretation of this partition wall because its eastern part was seriously damaged by one of the later pilasters abutting its inner face. A suggestion that this space was accessed from the south can be made. The area in front of and inside the space was covered by tegulae; the pavement is partially preserved and was probably laid down simultaneously with the erection of the wall. The L-shaped pilaster was built at the same time as the basilica and the enclosure wall and probably supported a construction connected to rooms at different floor levels of the tower. The depth of the foundations as well as their construction is identical to those of the basilica. Massive pilasters measuring 1.4 x 1.3m abutting the eastern part of the northern and the eastern enclosure walls at a distance of 2 – 2.5m from each other were built during the next construction phase of the architectural complex. They probably supported a loft or rooms on the upper floor (fig. 6).

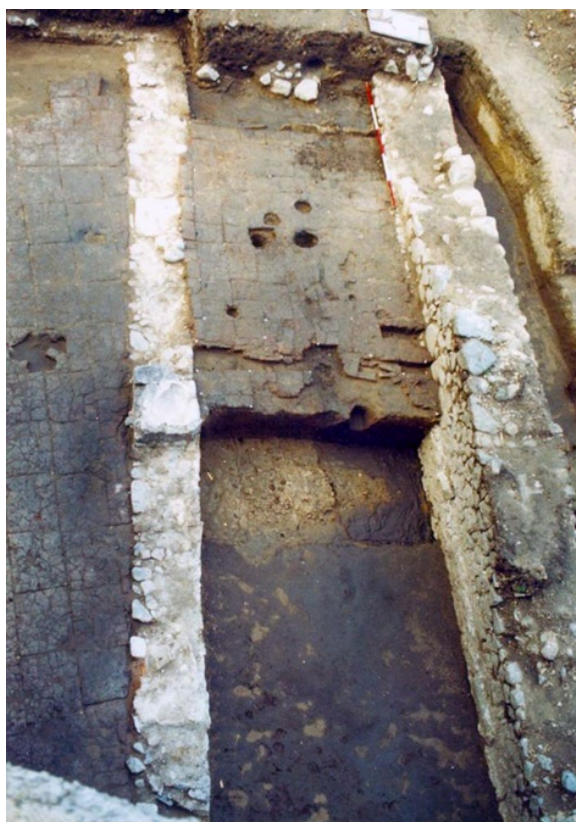
Fig. 7. Portico at the western enclosure wall.

A portico was constructed in front of the narthex along the inner face of the western enclosure wall at the same time as the portico (fig. 7). It was 2.9-3m wide and probably had reached the northern enclosure wall. Its construction has also disturbed the bipedal brick pavement. The space covered by the portico was not paved at that period but much later, during the reconstructions in the 6th century and was related to some kind of household structures. The excavations provided the following information about the construction of the portico: the stylobate is 0.70-0.72m wide and column bases made of massive stone blocks or large size stones were found *in situ*. Most probably there were six bases. Some of them have been poorly preserved (the two from north are destroyed by the modern construction trench). The bases are as wide as the stylobate; their length varies from 0.7 to 0.9m and the distance between them is 1.9-2m. The

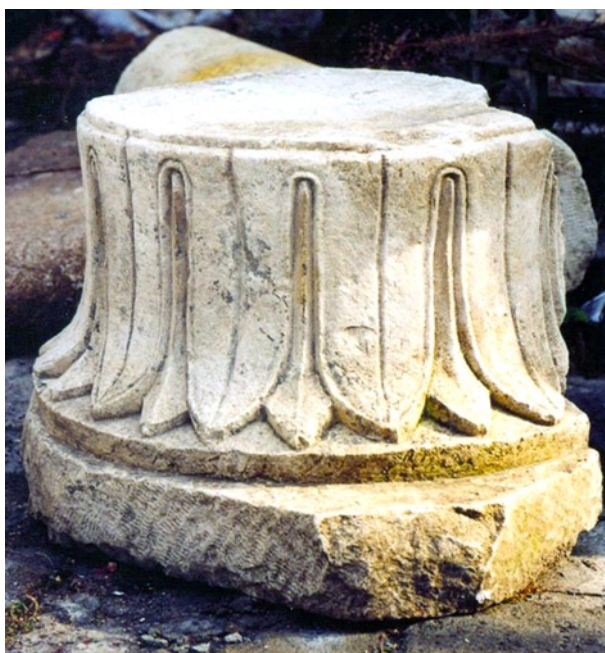
Fig. 8. Capital from the portico at the western enclosure wall.

upper part of some is plastered with mortar; mortar was also used to bind them to the stylobate. The debris in the courtyard yielded various architectural details – column sections, capitals and bases – providing information about the colonnade order. The columns had a base consisting of a rectangular plinth placed in a bed and a cylindrical shaft. The shaft consisted of two sections, each of them 0.9 m long. There was a small reduction in the diameter along the height of the column sections. They had been pegged together using metal pins. The columns had been crown with cylindrical capitals with a quadrangular abacus. The capitals were carved with palm or lotus leaves (fig. 8).
