THE CONCEPT OF AUTHENTICITY IN BYZANTINE CHURCHES - THE CASE OF REPUBLIC OF MACEDONIA

Панче Велков

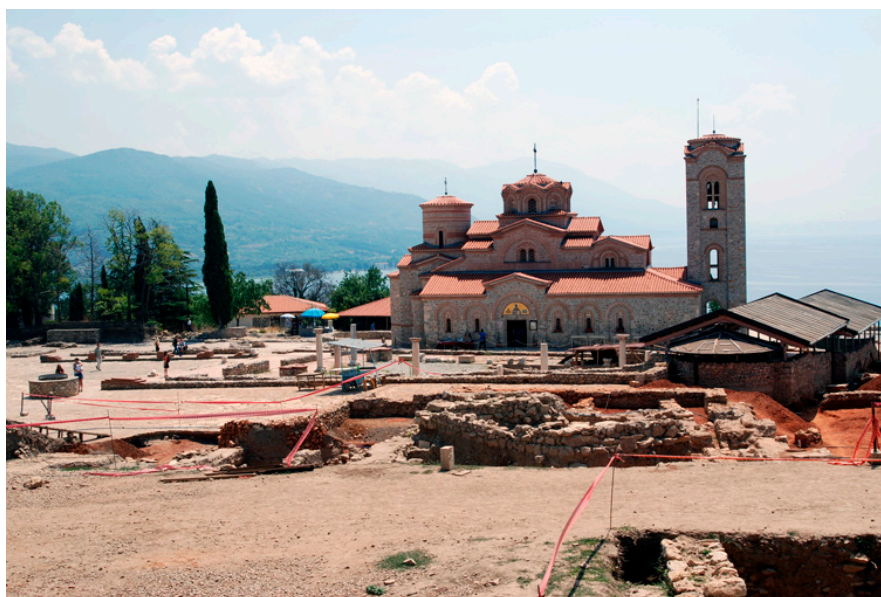
Fig 1. Saint Clement's Church in Plaoshnik, Ohrid

today. The reconstructed Saint Panteleimon church was built on the foundations of the medieval church after an extensive excavations and reconstruction works on the site. The works were completed in 2002 and Saint Clement's relics were returned to the reconstructed church – figure 1.

The plan of the reconstructed church follows the plan of the IX century church. However, due to the fact that there was very little evidence about the architecture of the original church, the architects built the new church inspired by the existing Byzantine churches in Macedonia. This is to say, Saint Clement's church on Plaoshnik is not an identical reconstruction of the original church. However, there are authentic features in the new church. The visitors can see remains of the original foundations of the IX century church covered by glass windows on the floor of the new church, as well as fragments of fresco paintings from the XIV century found during the excavations and now on display at the interior of the church. But most importantly, the visitors and the believers can see and venerate the relics of Saint Clement in a new tomb built in the interior of the church.

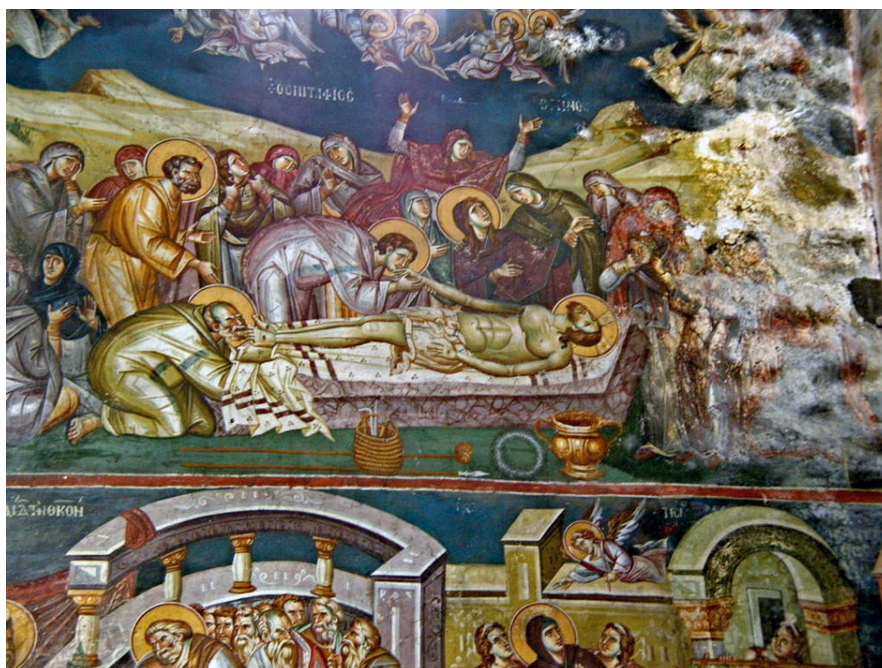
Fig 2. Church Holy Mother of God Peribleptos, Ohrid, Damaged Frescoes

Without entering in details of the conservation project , (inadequate and insufficient description of the damage patterns, lack of diagnosis of the damage cause and alike), it is important to notice that the project on paper and in reality, does not take the preservation of the authentic aspects of the church as a priority. The first and the second year of the project were spent on extensive geotechnical investigations as well as on archeological excavations , outside and inside the church . Only last year (2011) the roof containing cement was removed and replaced by a temporary roof made of wood (figure -3) . There was practically no work done on the site in 2012. In November 2012 , rain was pouring into the church on front of the altar, an obvious sign that the temporary roof is no longer protecting the church. And most importantly, in three years (2009 - 2012), practically no conservation works per se was done to protect the frescoes, apart from cleaning of the frescoes on a surface of only two square meters on the northwestern wall, where white salts had been eating out the frescoes very rapidly.

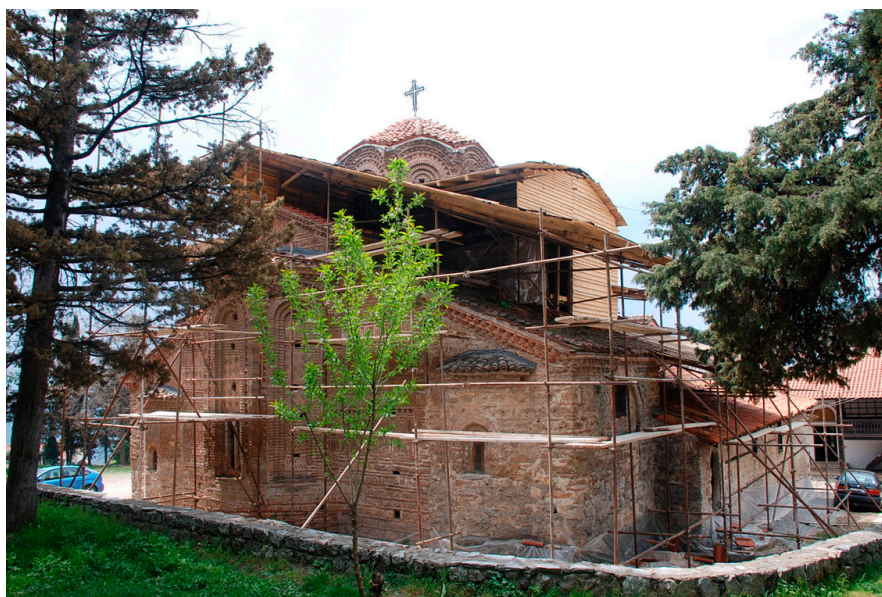
Fig 3. Peribleptos Church, Conservation

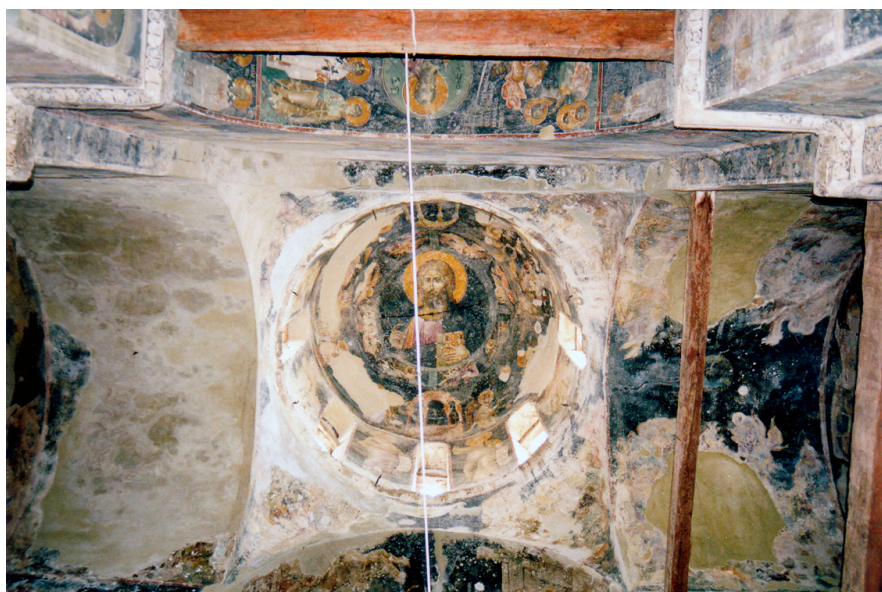
Fig 4. Church Saint George , Staro Nagorichane, Central Dome

The church Peribleptos in Ohrid is not an isolated case. The second master piece of Michael Astrapas and Eytichios, the church Saint George in Staro Negorichane painted in the second decade in the XIV century is also in a bad condition. Due to lack of maintenance and bad conservation, the frescoes in the church are in a very bad state⁵. In the upper parts of the church, in the domes in particular there can be noticed a significant loss of fresco pigments – figure 4. In some cases, like in the northwestern dome, there is a total irreversible loss of fresco pigments and painting as well – figure 5. In the Fall 2011 important level of moisture in the central dome was noticed. The moisture eats out the fresco decoration and destroys the fresco layers⁶.

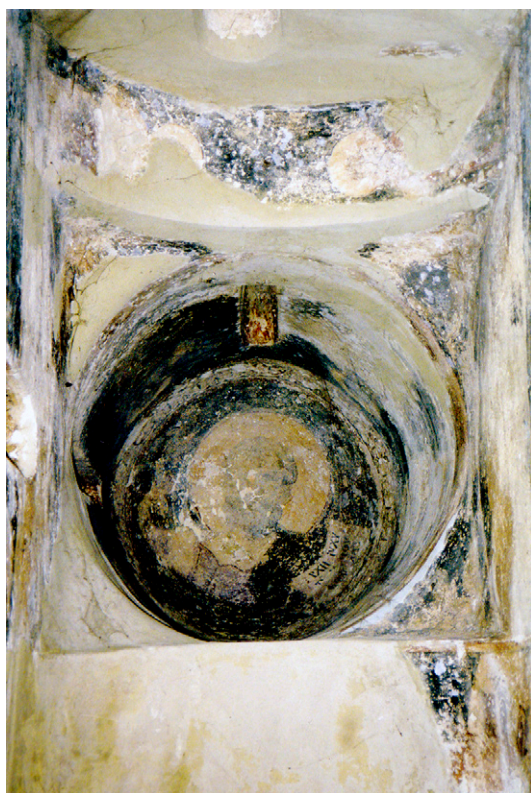
Fig 5. Church Saint George , Staro Nagorichane,
North-Western Dome
